*Ivan Janotka
Michal Bačuvčík
Patrik Ševčík
Peter Paulik*

Fizyczne i chemiczne parametry 124-letniego mostu z betonu zbrojonego

PHYSICAL AND CHEMICAL STATE OF 124 – YEARS OLD REINFORCED CONCRETE BRIDGE

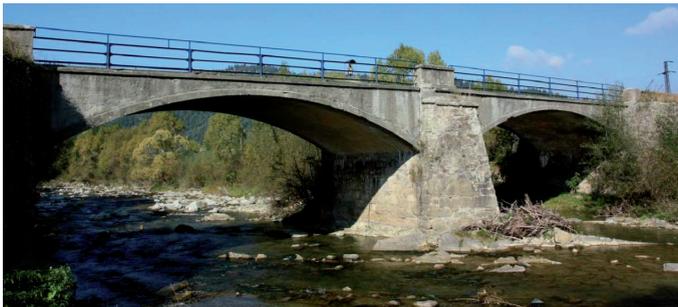
Fig. 1. Bridge in Krásno nad Kysucou before reconstruction in 2013

This unique bridge with the statue of Saint John of Nepomuk placed within its railing was in a very good technical condition after 124 years in service with hundreds of cars passing it every day on the former 1st class road between Žilina in Slovakia and Zwardoń in Poland. However, due to the increased demands for its reliability, in terms of new European standards, and also due to the effort of the city administration to maintain this technical monument, it was decided to refurbish and strengthen its structure as well as its approach roads.

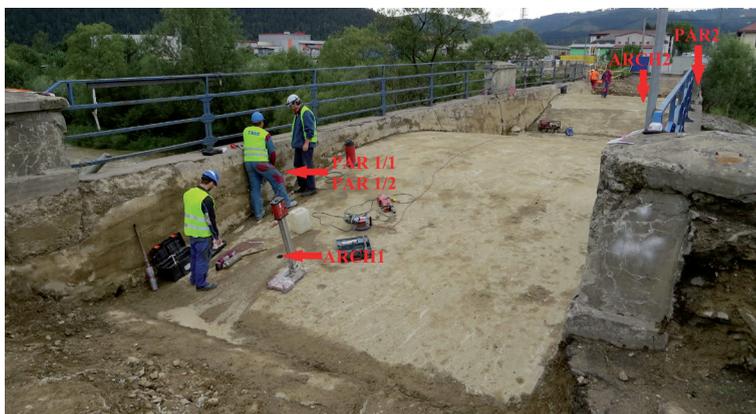
Localization of selected sites from the upper part of the bridge to gain cylindrical drilled cores is portrayed in Figure 3. The specimens for the consequent laboratory tests were taken by core drilling in the area of 1st and the 2nd arch and 2 parapets of the bridge Krásno and Kysucou (further are the specimens abbreviated as ARCH or PAR for the specimens

Fig. 3. The upper part of the bridge and notification of 4 sites for drilling bores

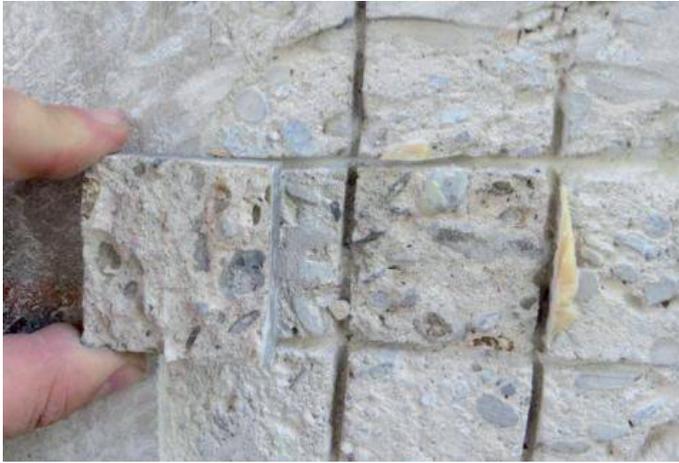
The test of adhesion of surface concrete layer to the deeper substrate is depicted in Figure 5 and the obtained results are summarized in Table 4. Tensile strengths showing the quality of the surface concrete at the bridge exceeded in all measurements the value 1, somewhere 2. This observation gives also the evidence on the preserved state of the concrete occurring at the bridge Krásno nad Kysucou.

Fig. 5. Estimation of the adhesion – teared off surface concrete layer

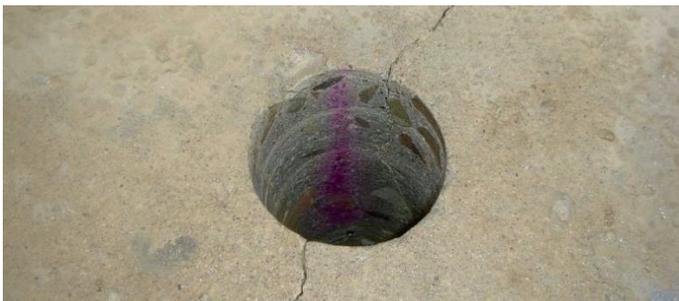
Carbonation of concrete was determined by a simple indicating method by phenolphthalein (0.1% solution in ethanol) to observe the depth of carbonation. The depth was measured immediately after drilling concrete cores by the distance of coloured layer oriented vertically to the surface of the structure as seen in Figure 6. The observed depths of carbonation are reported in Table 5.

Fig. 6. Verification of carbonating concrete layer on the superstructure of the bridge

The 124-old concrete is characterized by very surprisingly and unexpected low carbonation depth. However the previous finding on the well preserved state of concrete at the bridge structure is confirmed by this way. Contrary, the found low carbonation depths open the duty or at least the attempt to explain such “anomaly” in the terms of today’s concretes susceptible to carbonating. Low carbonation could be caused either by the type of cement, resistance of concrete itself due to concrete composition, method of making concrete and early curing storage and also long-acting external conditions. The research on this topic is focused in 2016 for taking smaller concrete cores from the bridge to study in a more detail carbonation of the concrete. The repeated verification of carbonation depth from May 23 to 24, 2016 confirms previous findings of negligible carbonation of concrete of the arches and parapets.

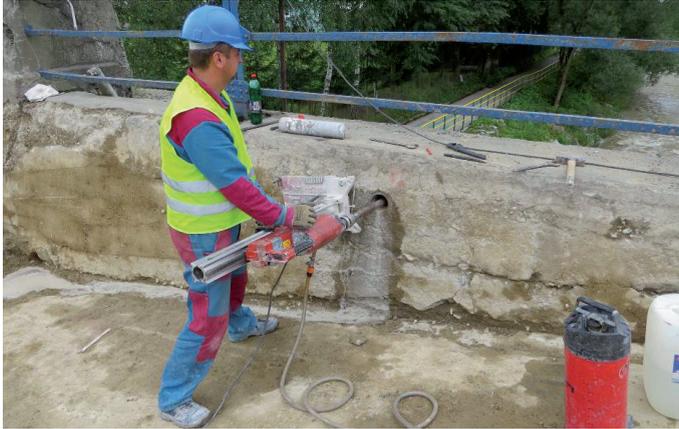
Figure 7 shows the necessary work for gaining core. Cylindrical specimens intended for laboratory tests are seen in Figure 8.

Fig. 7. Drilling the concrete core with diameter of 100 mm

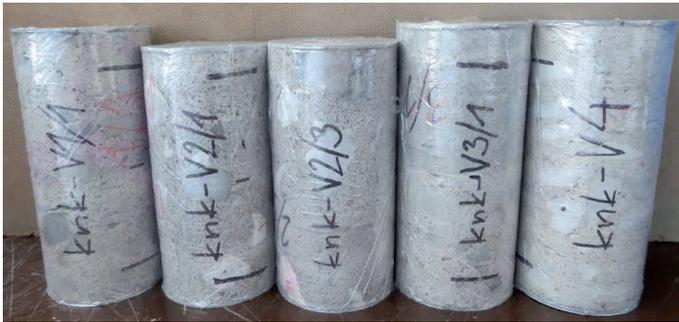
Fig. 8. The taken concrete specimens for dynamic and Young's modulus of elasticity and compressive strength testing in the laboratory

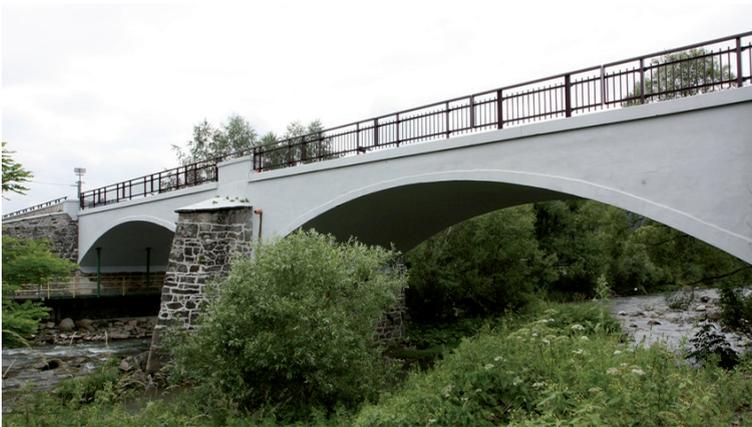
The current view of the renovated bridge is shown in Figure 13.

Fig. 13. View of the bridge after reconstruction

The results of in-situ and laboratory testing of the physical and chemical state of the concrete served as serious knowledge base for initiating and carrying out reconstruction of the bridge.
